# **Appendix 5A**

**County CASGEM Monitoring Plans**

## **CASGEM Monitoring Plan**

#### **Glenn County CASGEM Monitoring Plan**

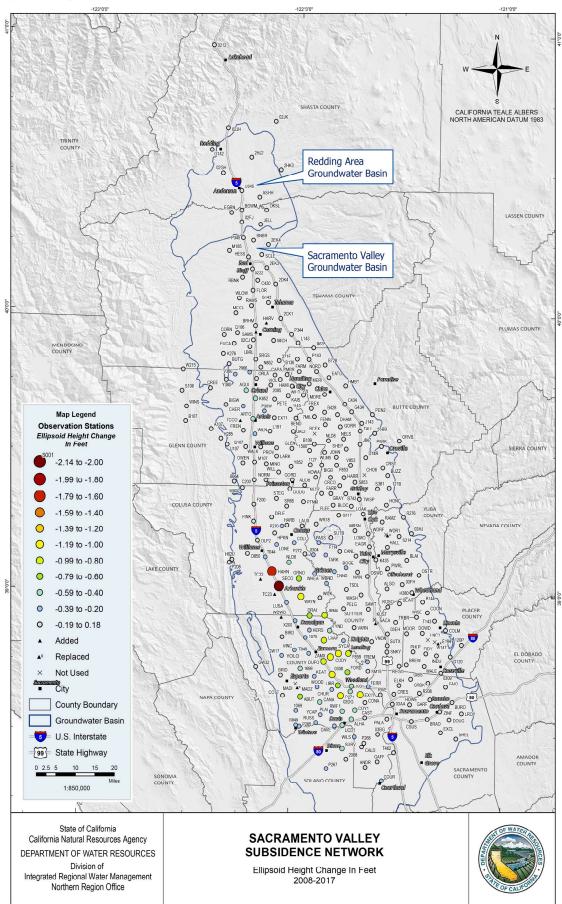
Figure ES-1 Height Change at Monuments between 2008 and 2017

The Arbuckle area (Colusa County) showed the most subsidence with a maximum change of -2.14 feet (ft.). Surrounding stations and InSAR data confirm this result with changes ranging from -0.49 to -1.00 ft. In eastern Yolo County (Zamora to Davis), the largest spatial extent of station declines was observed with several benchmarks showing changes between -0.3 and -1.1 ft. In Glenn County (Artois and Orland area), three stations, ARTO, K852, and AGUI showed changes of -0.59 ft., -0.46 ft., and -0.44 ft., respectively. An area on the south side of the Sutter Buttes showed changes ranging from -0.19 to -0.36 ft. The remainder of the valley shows little change overall. The results of the change between 2008 and 2017 are shown in Figure ES-1.

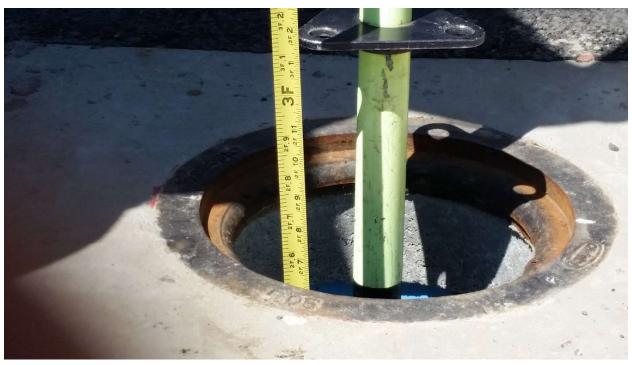
Figure 1-1 FERR Monument with Tripod in Place

At the FERR station it was necessary to add a 2-foot extension to the tripod for a total of 8.562 ft. (2.61 meters) because the construction of a new water intake structure on the Sacramento River raised the ground surface nearly two feet, putting the monument below the surface by over 2.5 ft. (Figure 1-1).

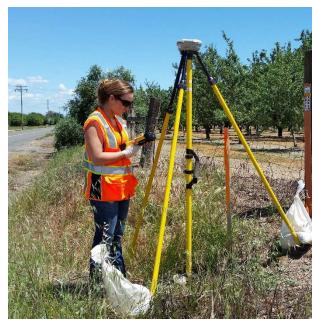
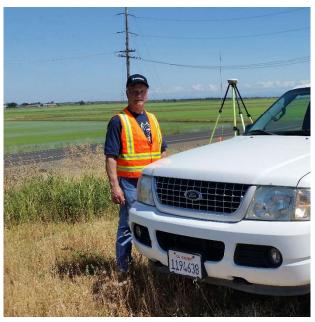
Figure 2-3 Hether Ward (Glenn County) at Station Peter and Jerry Peatross (Placer County Water Agency) at Station Hallwood

Despite the limited amount of surveying experience of the observers, phase two was completed successfully, and the observers were able to complete their tasks of traveling to the station and locating the monuments, setting up and operating the equipment, and filling out the GPS Observation Logs. As previously stated, individuals from multiple agencies participated in this effort. A complete list of observers is shown in (Appendix D) and without the support of staff from the cooperating agencies, this project could not have been completed. Figure 2-3 shows a couple of the observers set up on stations.

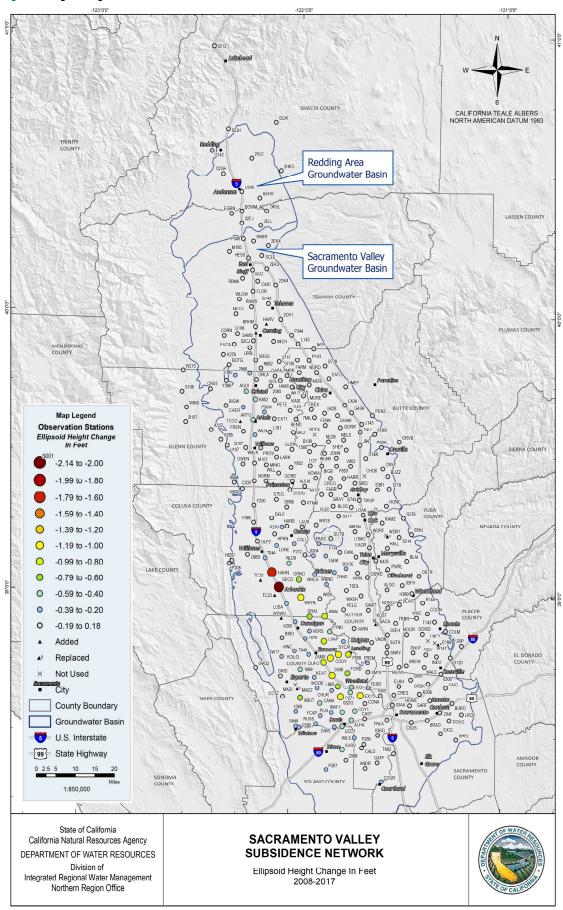
Figure 3-1 Height Change at Stations between 2008 and 2017

With GPS, as with any type of measurement, there is some amount of error. For GPS measurements, the primary sources of error come from signal delays caused by the troposphere and ionosphere, poor satellite geometry (known as Position Dilution of Precision or PDOP), and multi-path where the signals from the satellites reflect off an object before reaching the GPS receiver. Additional errors may occur from clock timing and clock synchronization errors. These errors or "noise," creates an error of uncertainty of approximately 0.17 ft. (5.2 centimeters). Therefore, any change less than 0.17 ft. is not considered statistically significant. The results of the differences for stations that have previously measured ellipsoid heights can be seen in Appendix G and graphically in Figure 3-1.
